Bird and Bat Guano and its effect on conservation and maintenance

TIM HUTTON, DAVID WATT AND JENNY BROWN

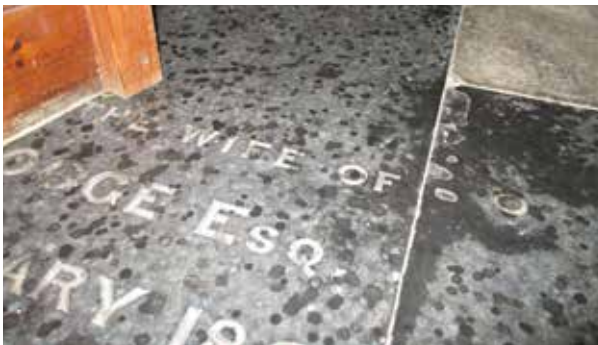
Bat urine stains on a church stone floor.

Bat urine is also acidic and can cause irreversible damage to materials. In historic churches, for example, bat urine can cause staining on brass, marble, slate and polished timber, and may damage porous surfaces such as stone and terracotta.

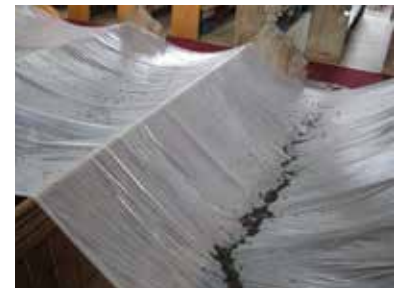
Bat droppings accumulated over a short period of time on protective sheeting.

While it may be possible to encourage bats to roost in a different part of a building, it is more likely that surfaces will need to be protected. The use of sheeting over fixtures and fittings

offers a solution but is unpopular with congregations and visitors as it is obtrusive and requires regular cleaning or replacement. Smaller, bespoke covers can be used over certain items, such as altars and lecterns, and these can be designed to co-ordinate with other fabrics in the building.
